NASA TECHNICAL
MEMORANDUM

NASA TM X-64844

MSFC SKYLAB NEUTRAL BUOYANCY SIMULATOR

14. SPONSORING AGENCY CODE	
15. SUPPLEMENTARY NOTES					
16. ABSTRACT Presented in this report is the role of the Neutral Buoyancy Simulator in the development, crew training, and flight operational aspects of Skylab.

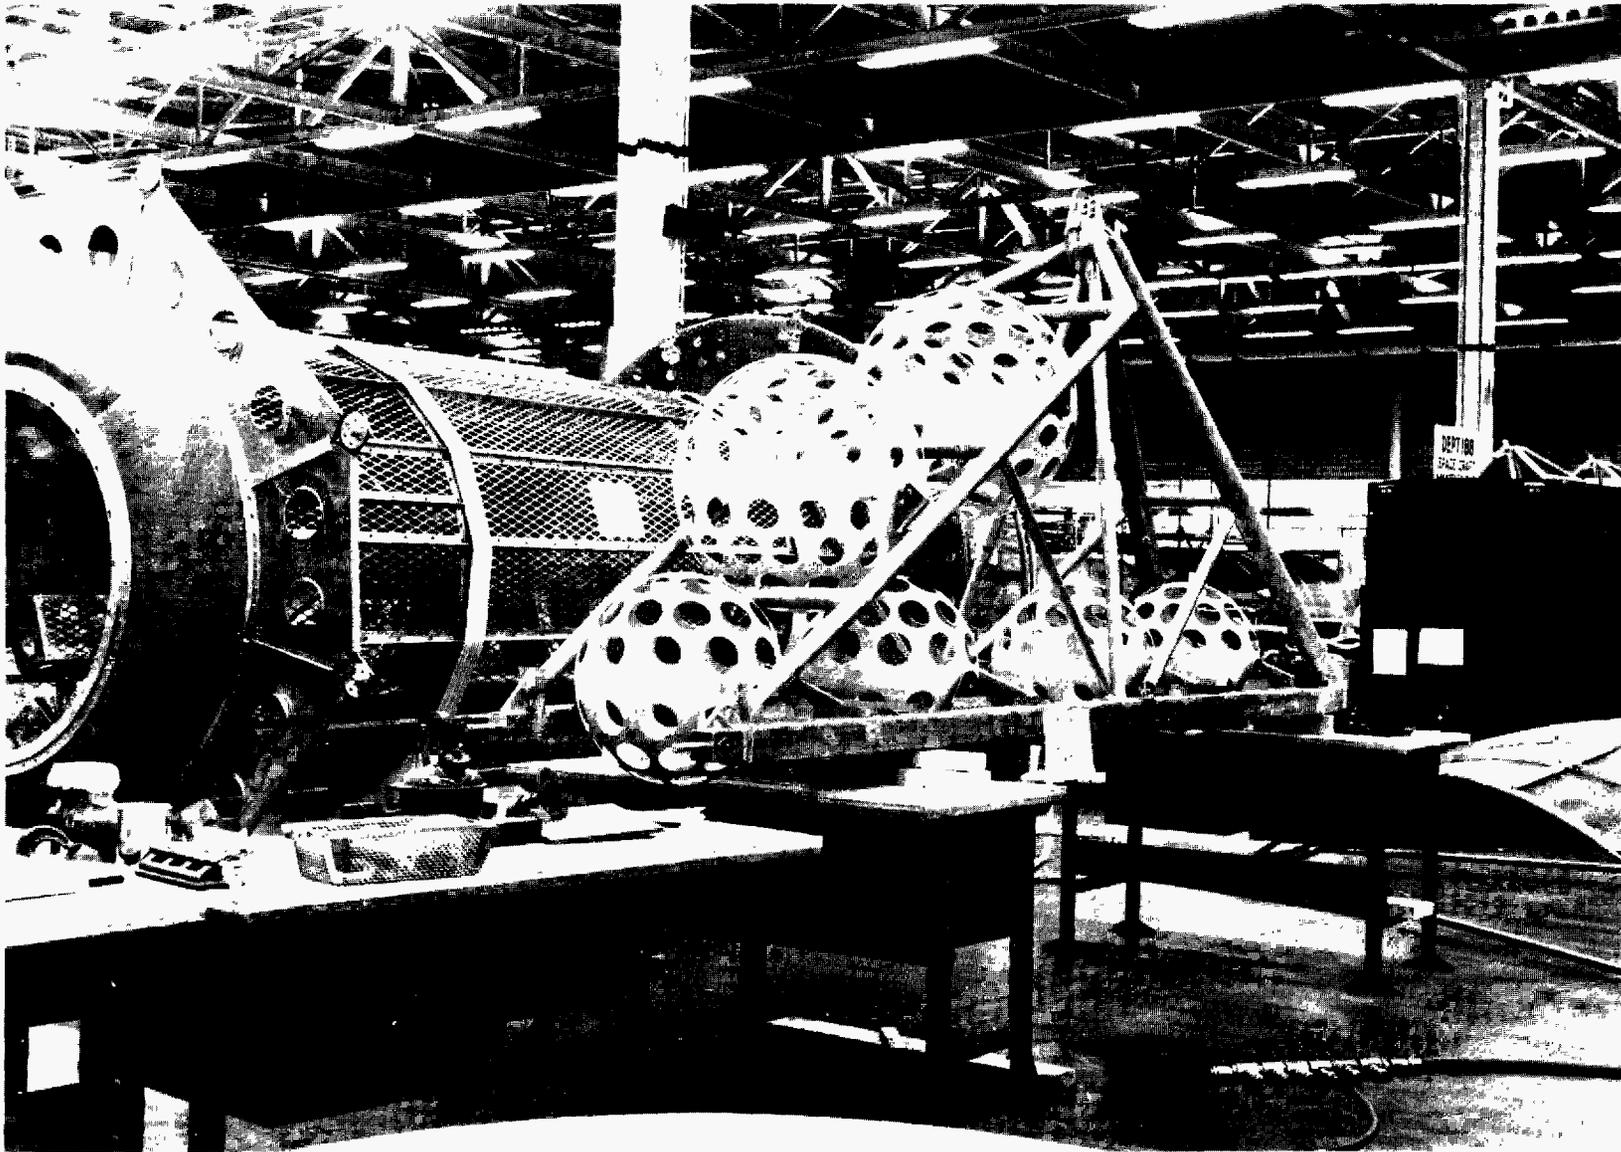
FIGURE 3-4 EARLY NBS AM TRUSS CONSTRUCTION WITH NITROGEN BOTTLES (WET WORKSHOP)

rings and channels, riveted to the skins. Original skins were expanded metal 3003-H14 aluminum .003m (.12 in.) thick; these were later replaced with solid 2024-T3 aluminum rolled sheets. Truss structure was .1m (4.0 in.) square 6061-T6 tubing with smaller diameter structural 6061-T6 aluminum tubing welded. See Figures (3-2, 3-3, 3-4, and 3-5).

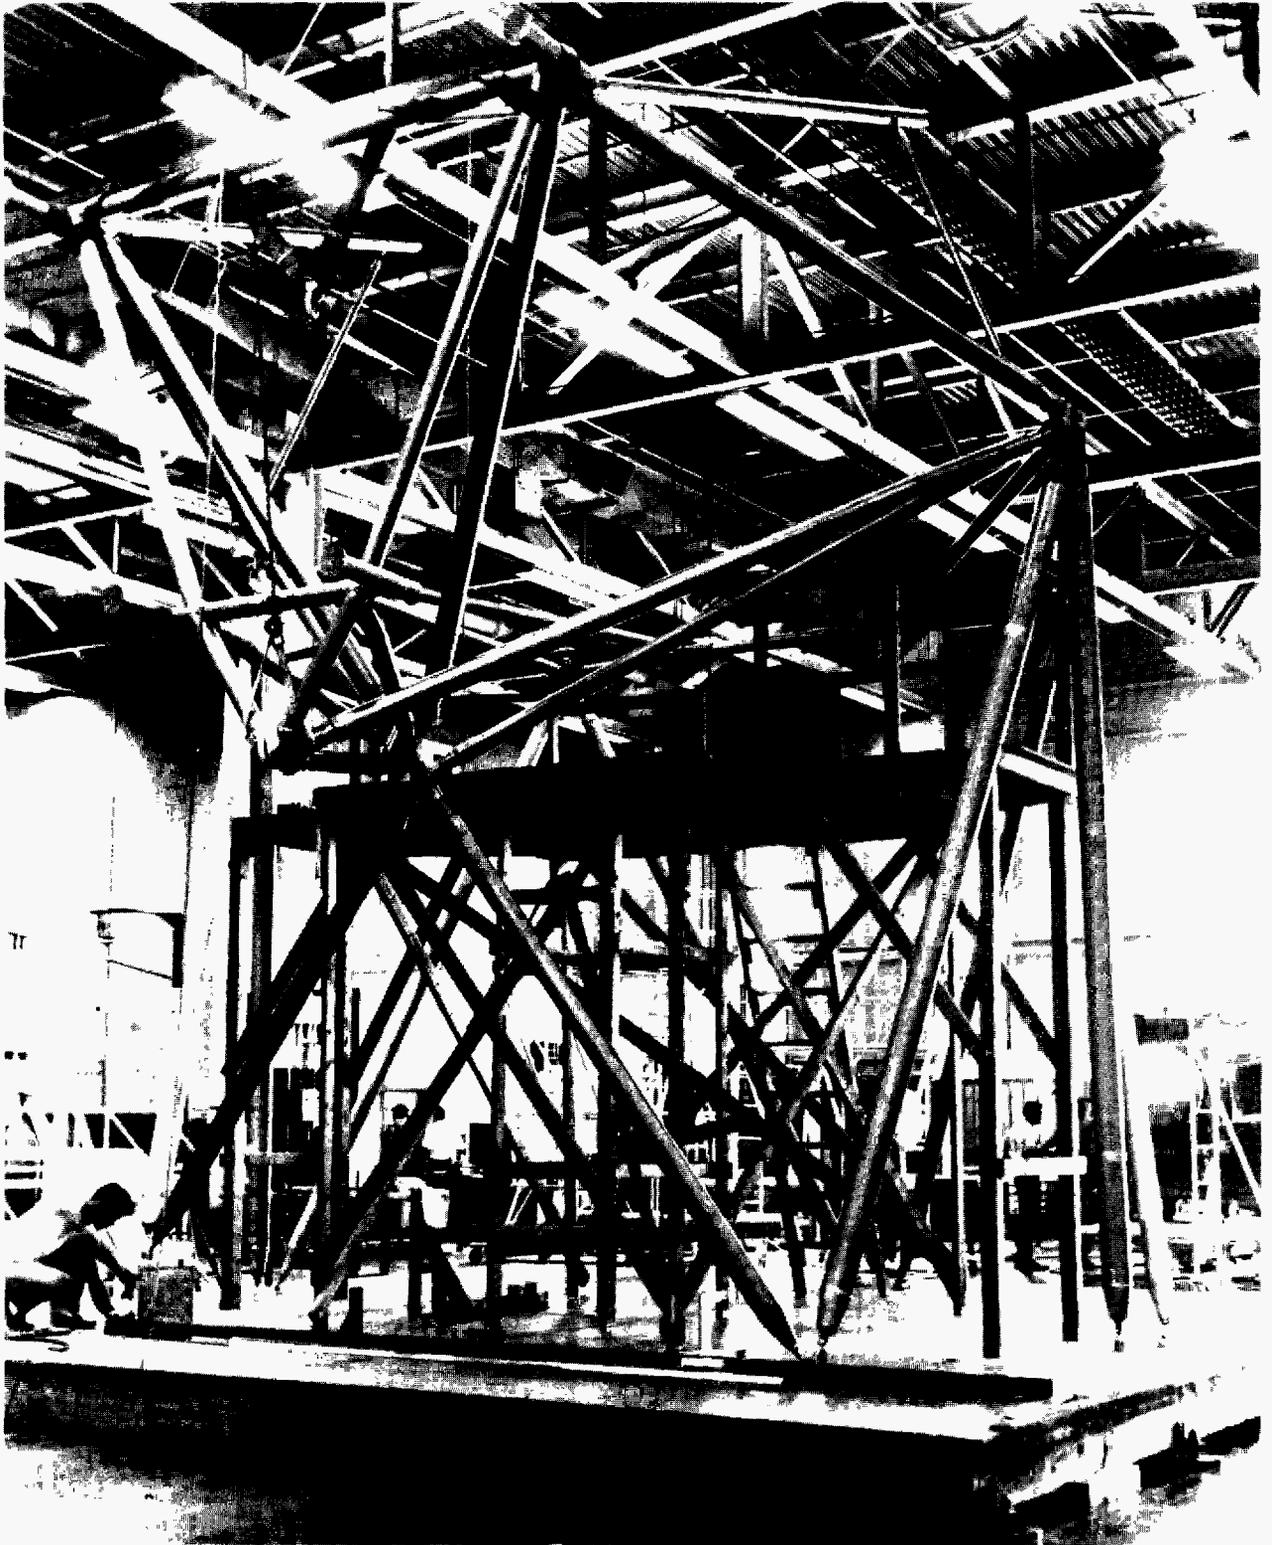
FIGURE 3-7 NBS DEPLOYMENT ASSEMBLY (DA)

The DA consisted of an upper and lower truss assembly. After orbit insertion, the upper DA truss was deployed 90 degrees around two trunnion points at the +Y and -Y axis, toward the -Z axis (sun direction). The NBS DA was a duplicate of the flight article, except that it was fixed in the orbit deployed position (see Figure 3-7). Also two additional struts were installed on the NBS DA for structural support from the floor of the tank. Original NBS units were fabricated by NASA-MSFC; later new, high fidelity assemblies were fabricated and installed by MDAC-E. Basic structure was welded bipods of 6061-T6 aluminum tubing. The lower truss assembly was attached to the FAS with welded 6061-T6 aluminum fittings. The upper truss was attached to the ATM with welded fittings and adapter rings. The two assemblies were joined together in the orbit position, with two stainless steel trunnion bolts and brass nuts. The DA contained high fidelity handrails that were essential in

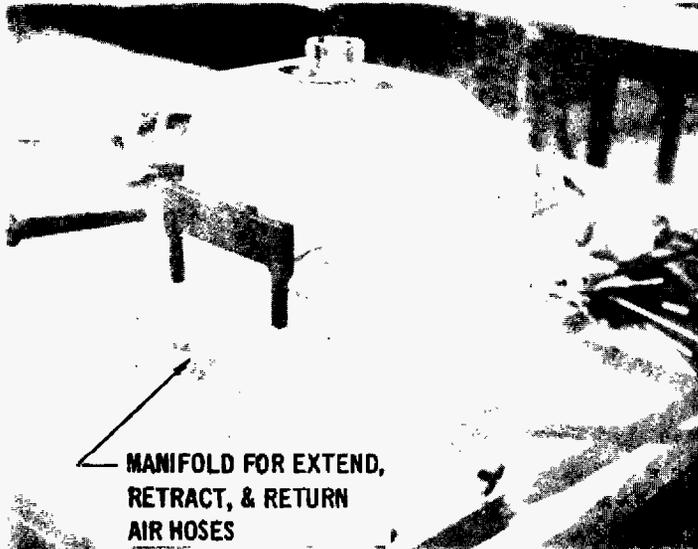
FIGURE 3-10 NBS PNEUMATIC EXTENDIBLE BOOMS

- o The flight boom electric motor was replaced by a pneumatic motor to eliminate motor sealing problems and electric current hazards in the water (Figure 3-10).
- o Special back-up drive rollers were incorporated, pressing harder on the boom element to prevent slippage underwater.
- o The NBS booms were modified by adding a check valve to the pneumatic drive system to permit extend/retract cycles (Figure 3-11).
- o Special sealing processes were developed by NASA-MSFC to seal the electric switches in the extendible boom control panel. The

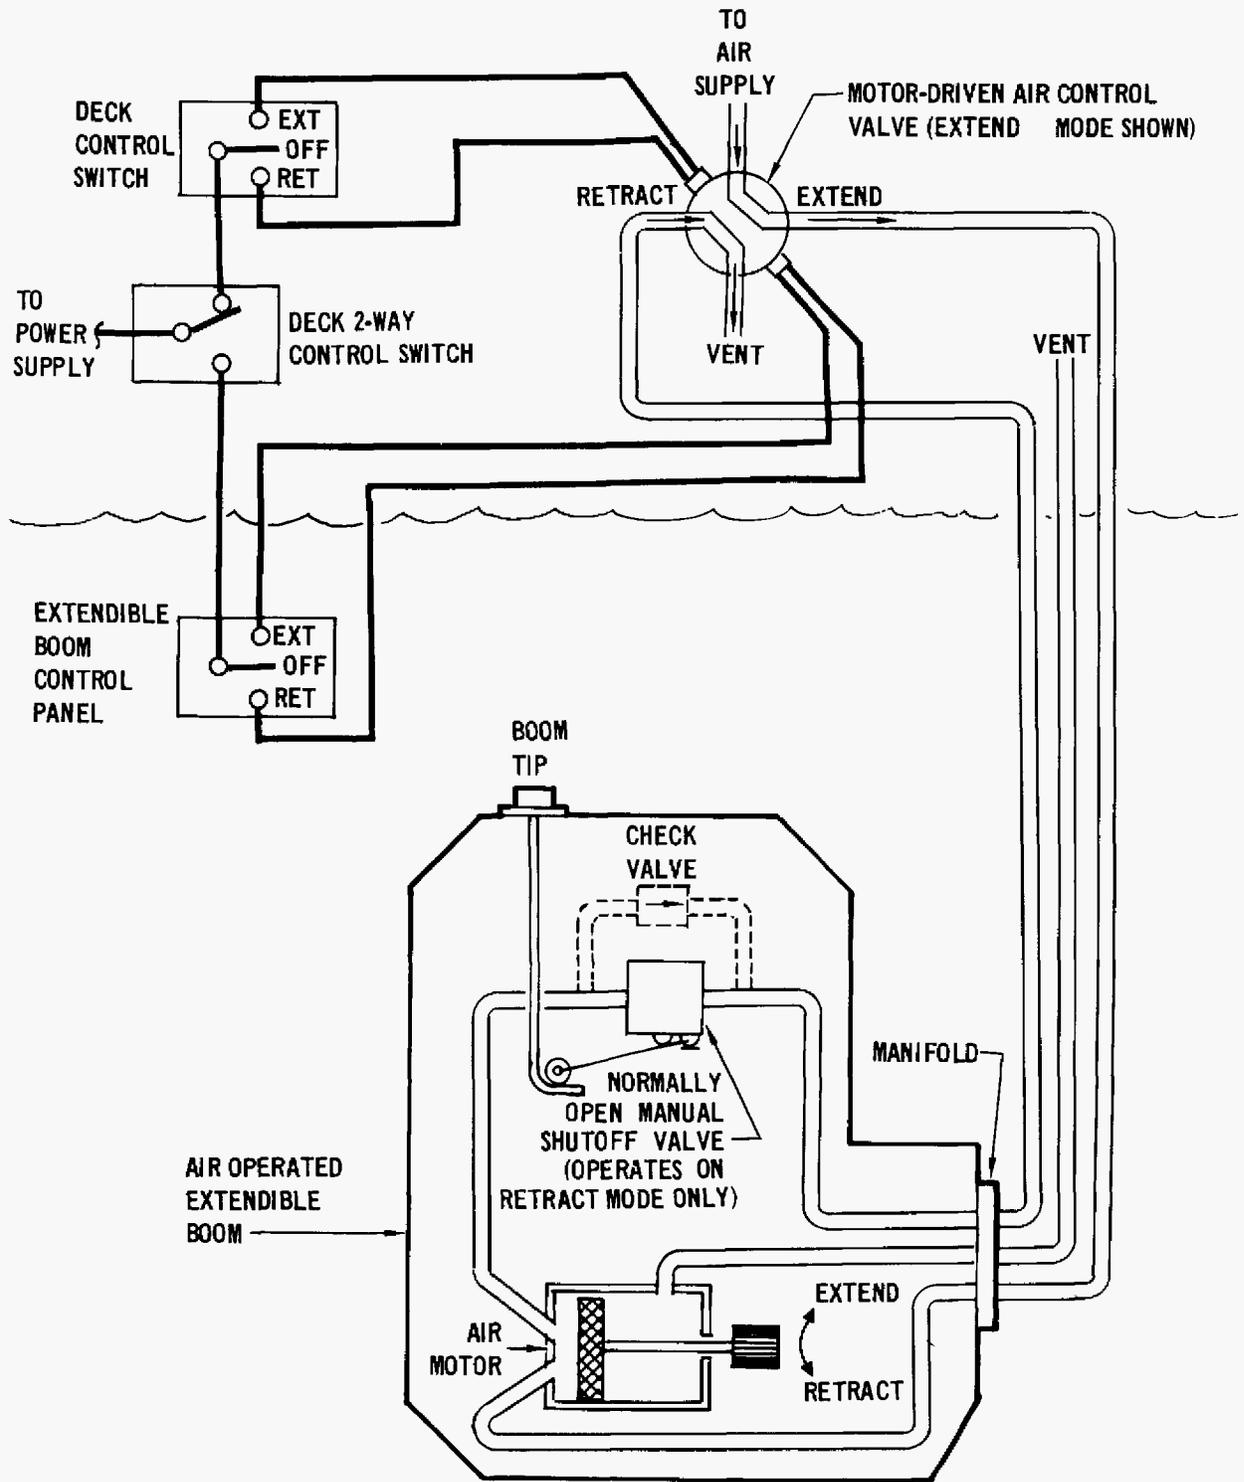
FIGURE 3-11 SCHEMATIC OF NBS AIR OPERATED EXTENSIBLE BOOM

submerged switches were wired to operate an air control valve located outside the tank which supplied air (at 80 psi) to the pneumatic motors for extension or retraction. A spare sealed and wired control panel was kept on standby status for quick replacement by SCUBA divers (Figure 3-12).

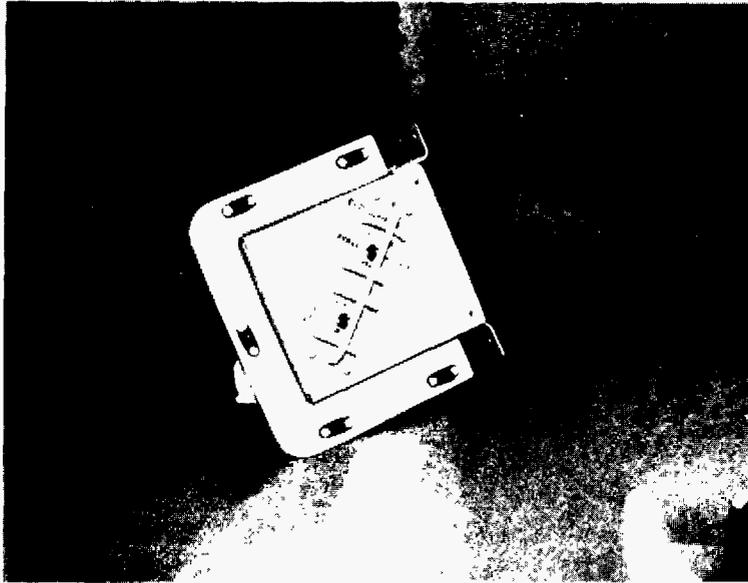
FIGURE 3-12 EXTENDIBLE BOOM CONTROL PANEL

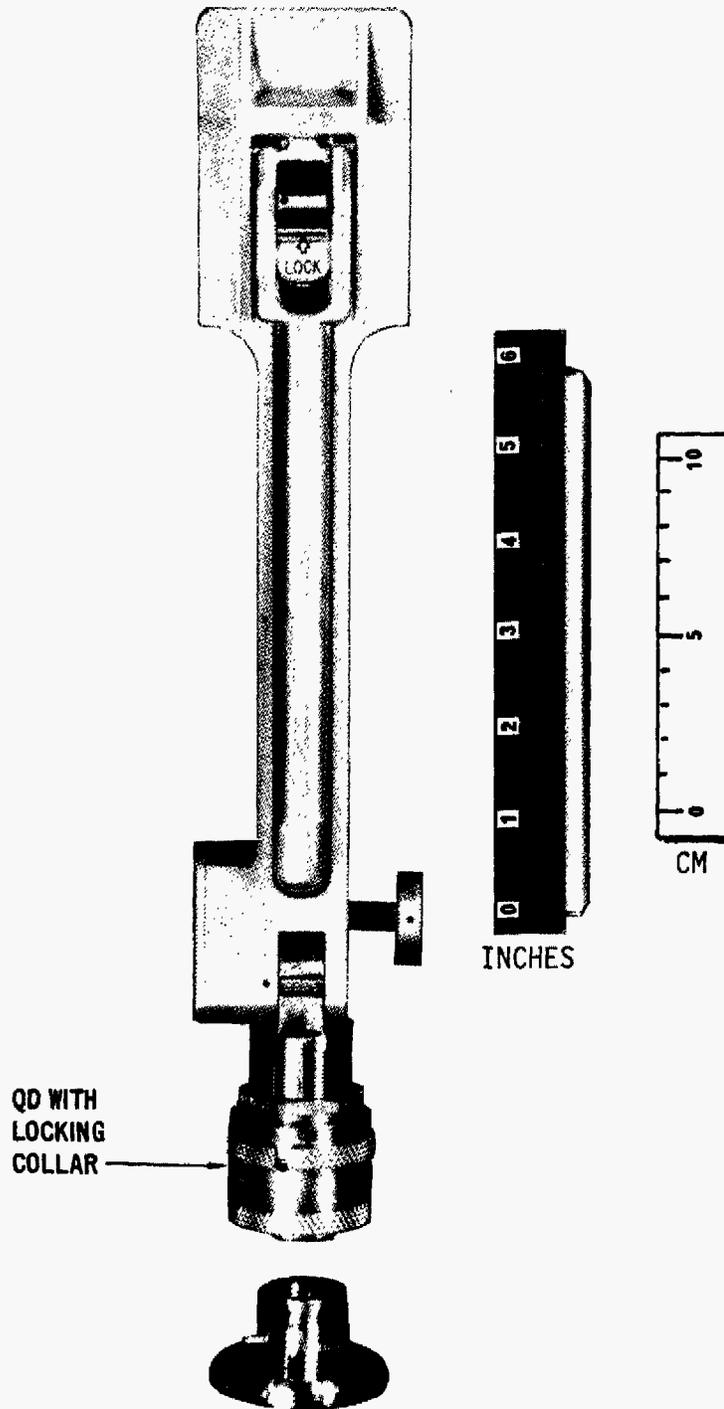
FIGURE 3-17 QUICK DISCONNECT BOOM HOOK

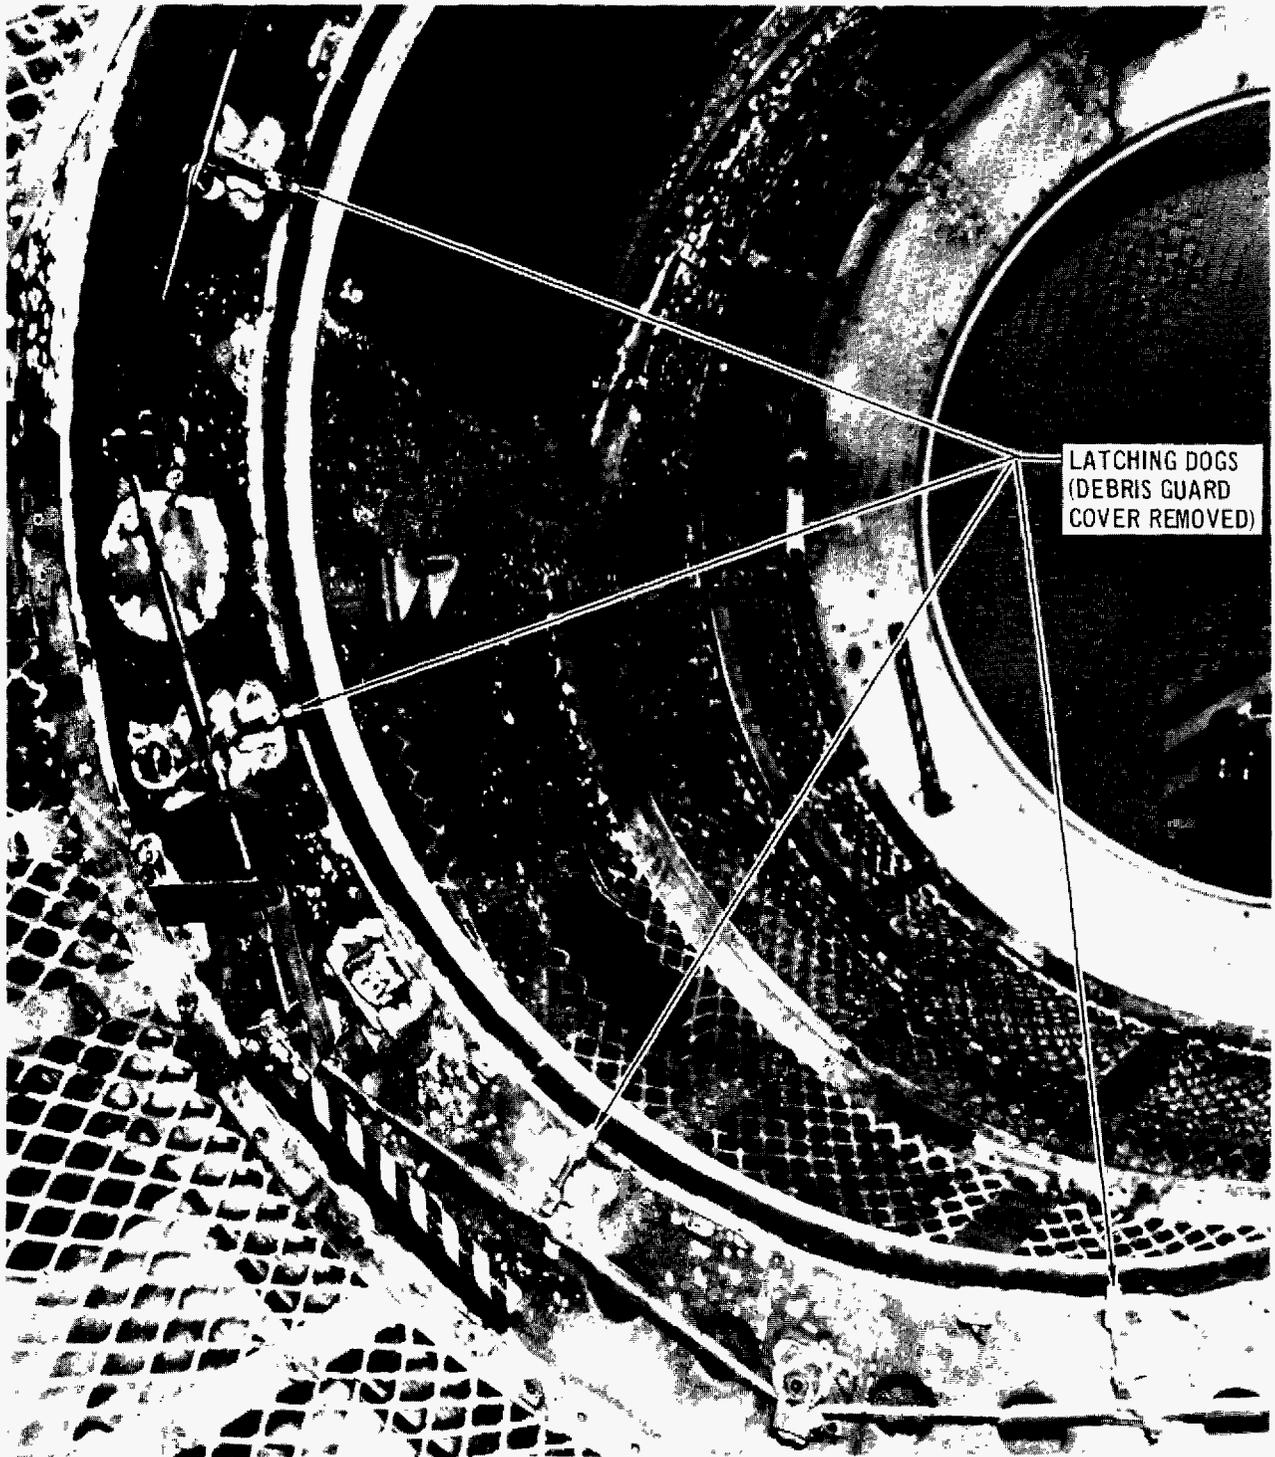
FIGURE 3-18 AM HATCH LATCHING MECHANISM

Internal hatches were low fidelity trainer articles and did not contain a sealing bead that compresses into the seal as on the flight article. Therefore a different type seal of slightly porous neoprene rubber was used. These seals presented load problems with internal hatches because the neoprene rubber continually absorbed water and swelled, which increased latching forces. A portion of the seal that protruded beyond the sill was trimmed completely off except for four pads approximately .072m (3.0 inches long. These pads closely simulated flight latching forces until water was absorbed in the open cell neoprene rubber seal. In approximately 60 days underwater, the latching force was out of spec. During the majority of training exercises, internal hatches were placed in the correct flight position by utility divers prior to beginning EVA procedures.

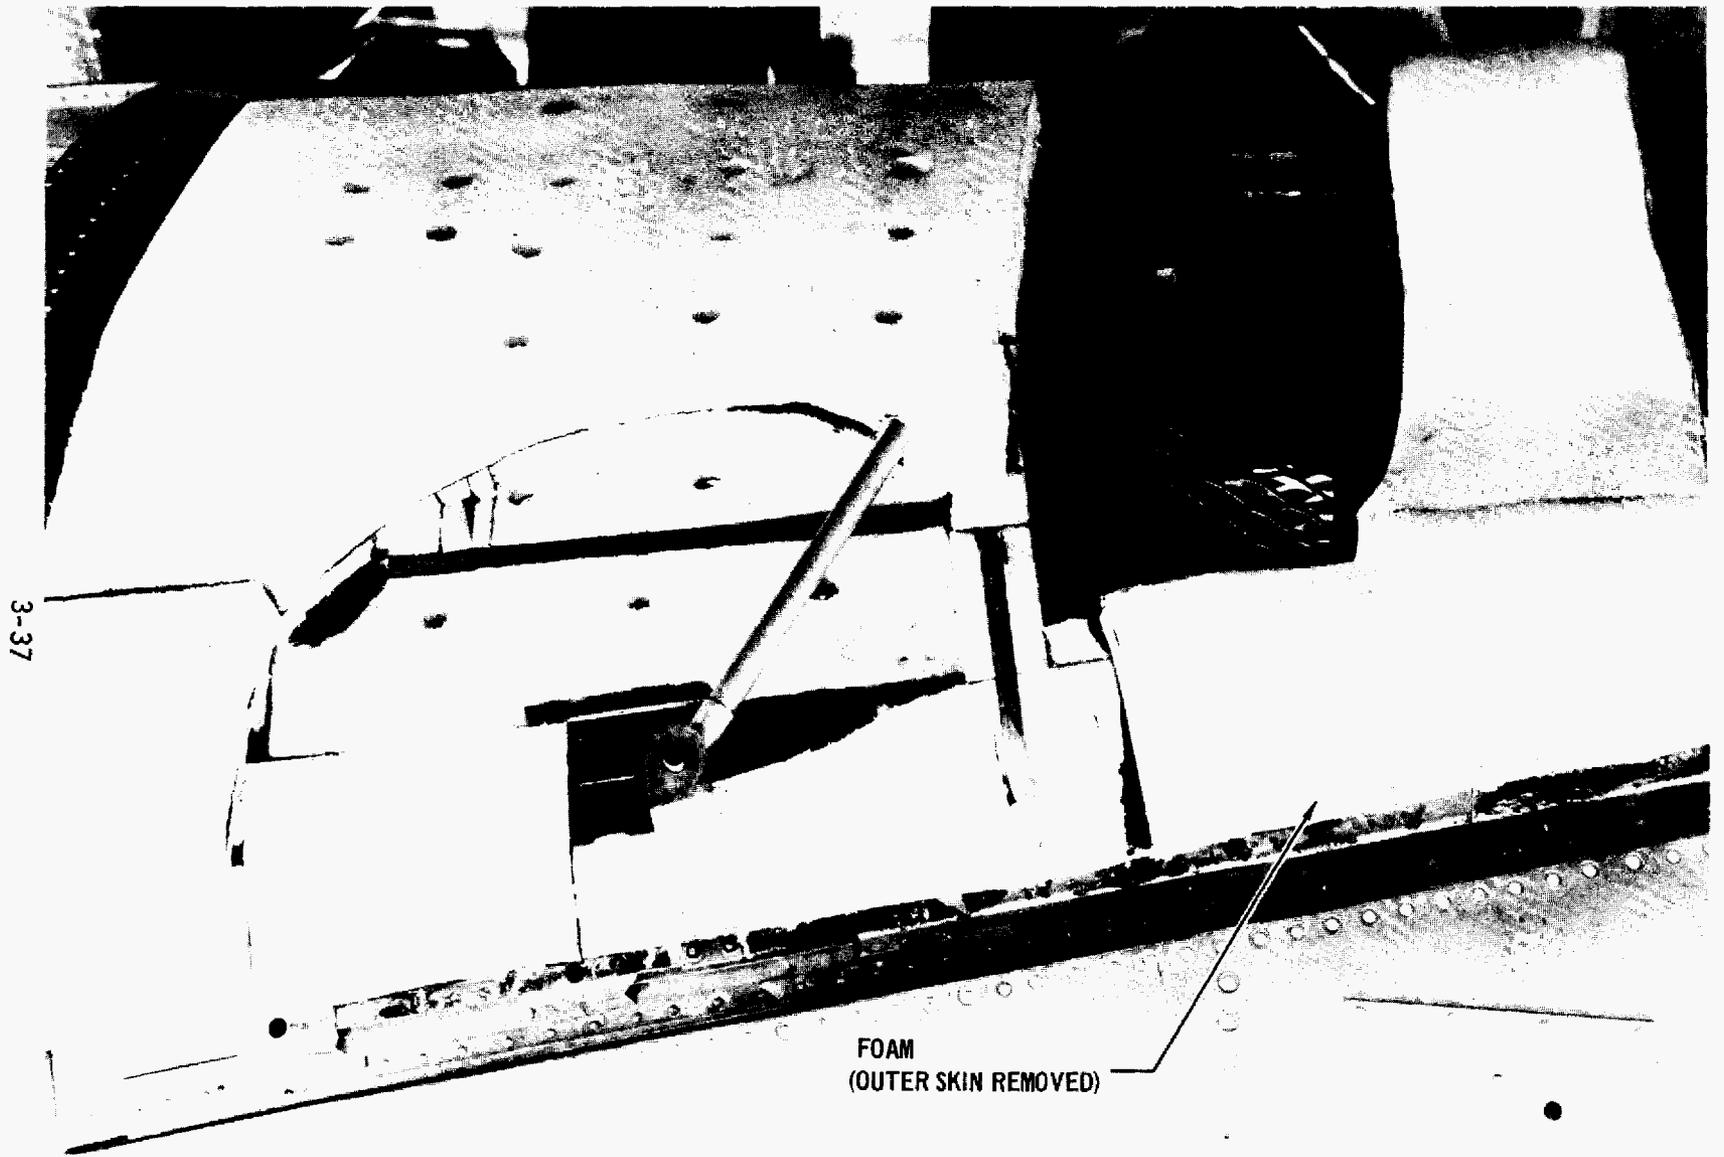
FIGURE 3-19 NBS EVA HATCH

The flight article EVA hatch had a retainer mechanism that allowed the hatch to open approximately .018m (.7 inch) when the handle was placed to the open position. This unit was installed to insure the hatch would not be blown open by lock residual pressure vented from the pressure suits.

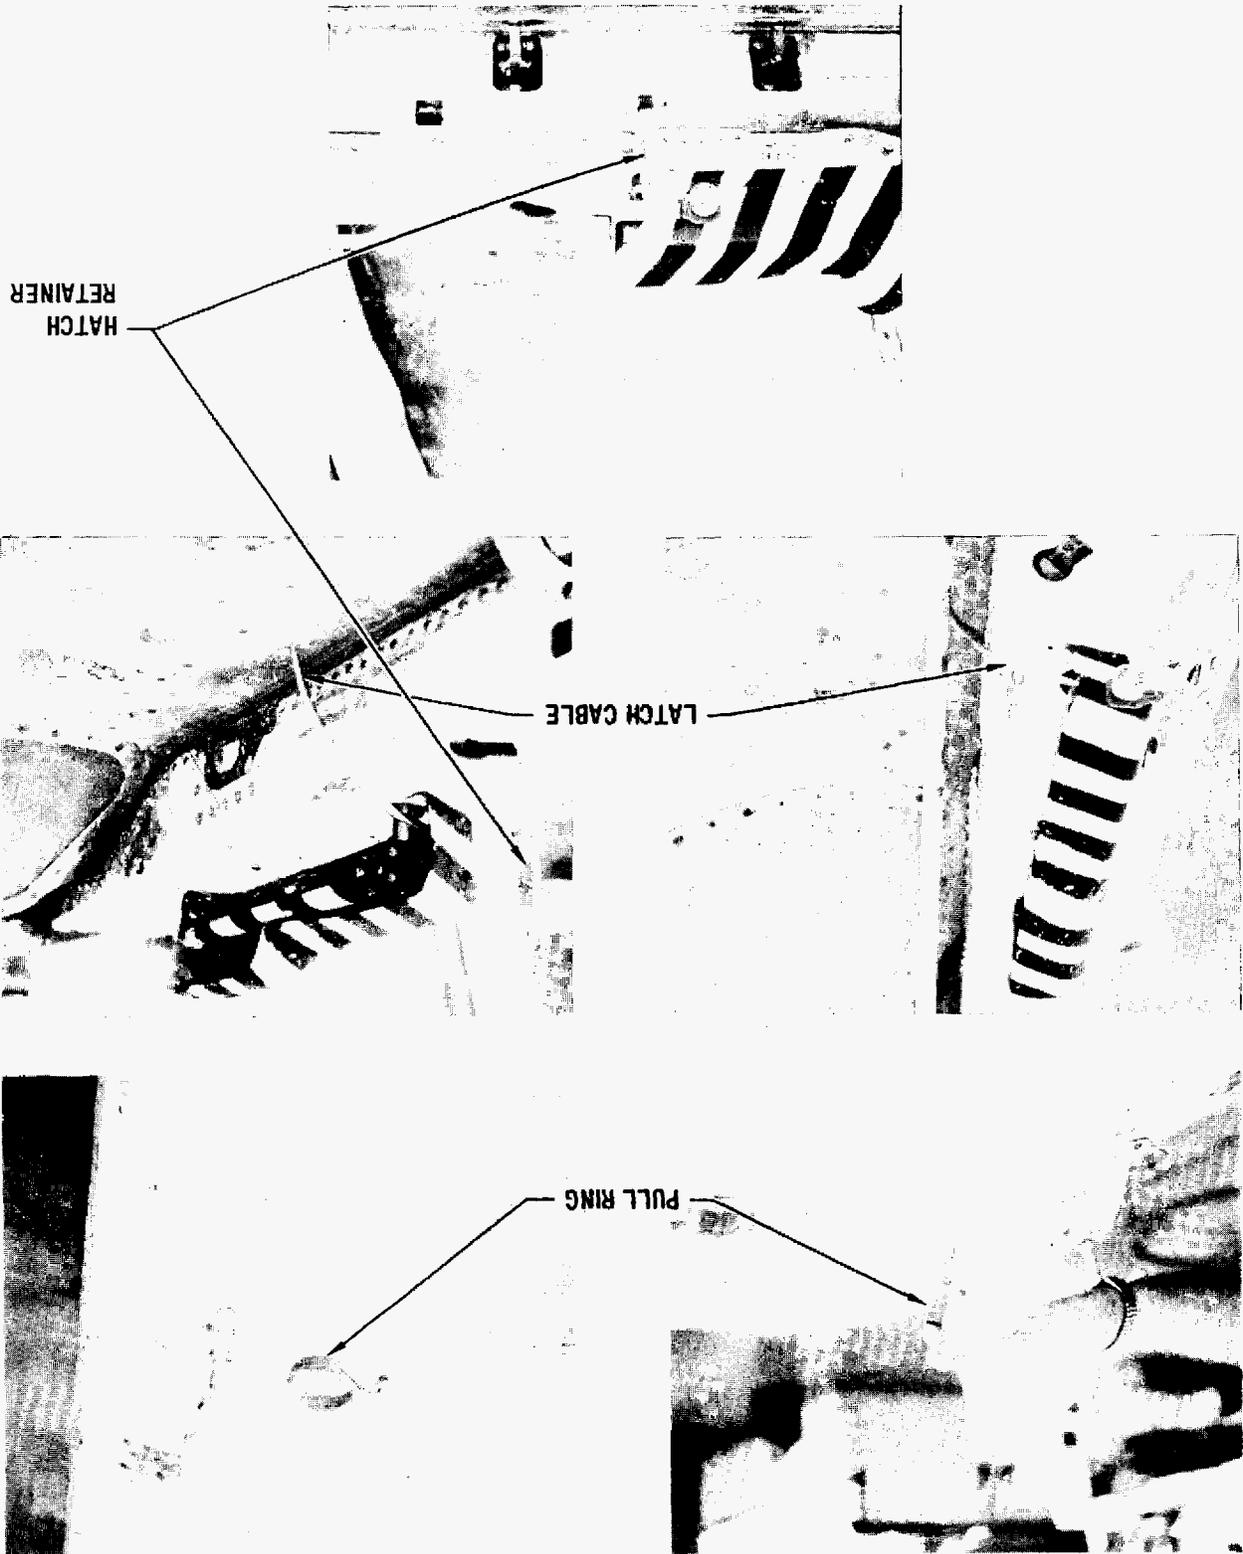
FIGURE 3-20 NBS EVA HATCH SAFETY RELEASE

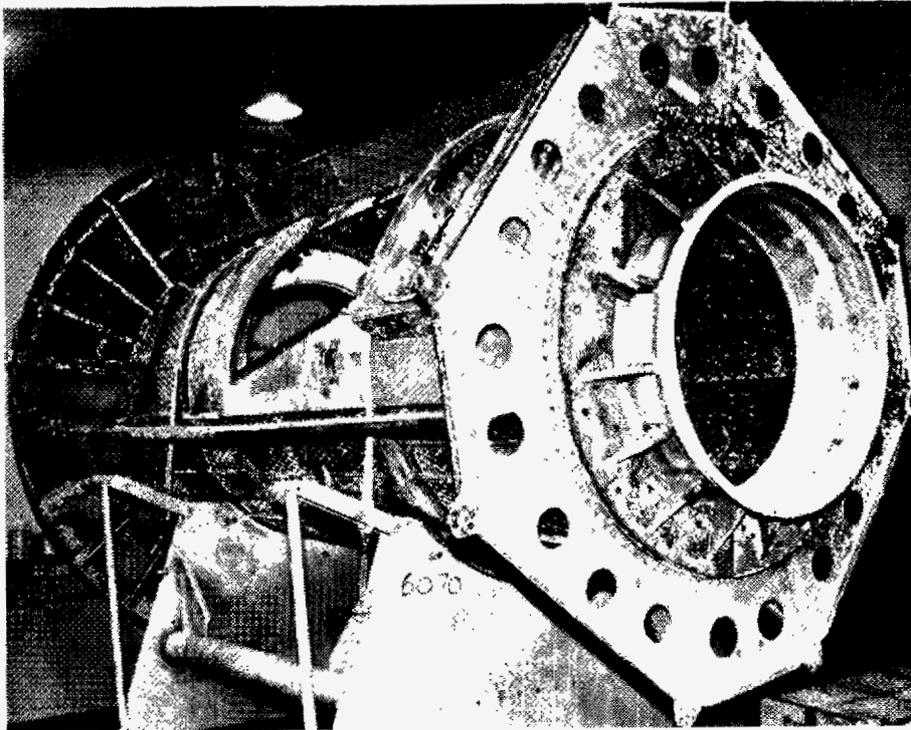
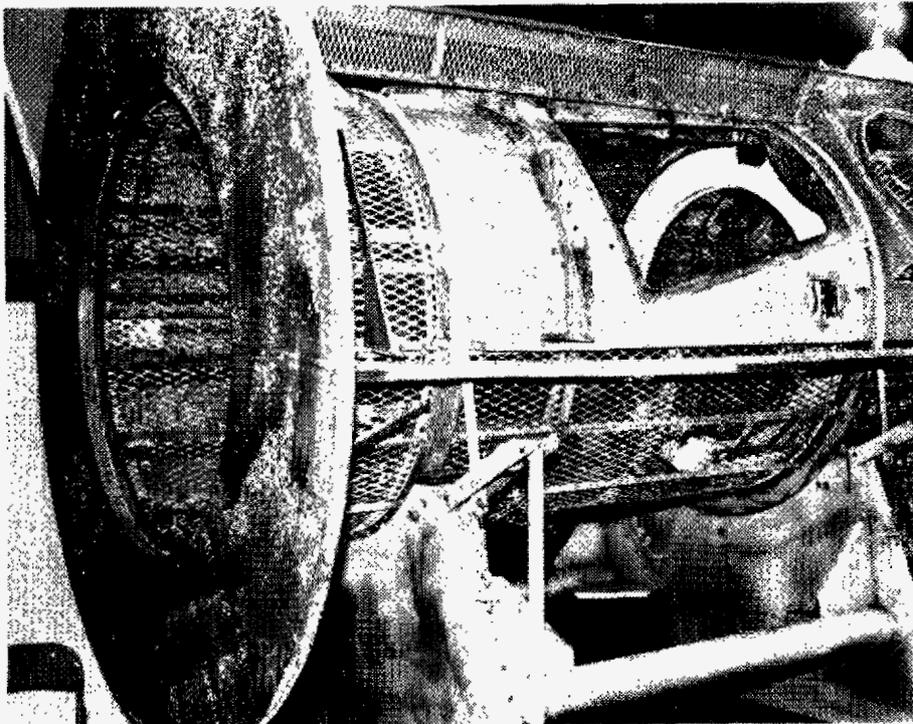
FIGURE 4-2 FASTENER CORROSION

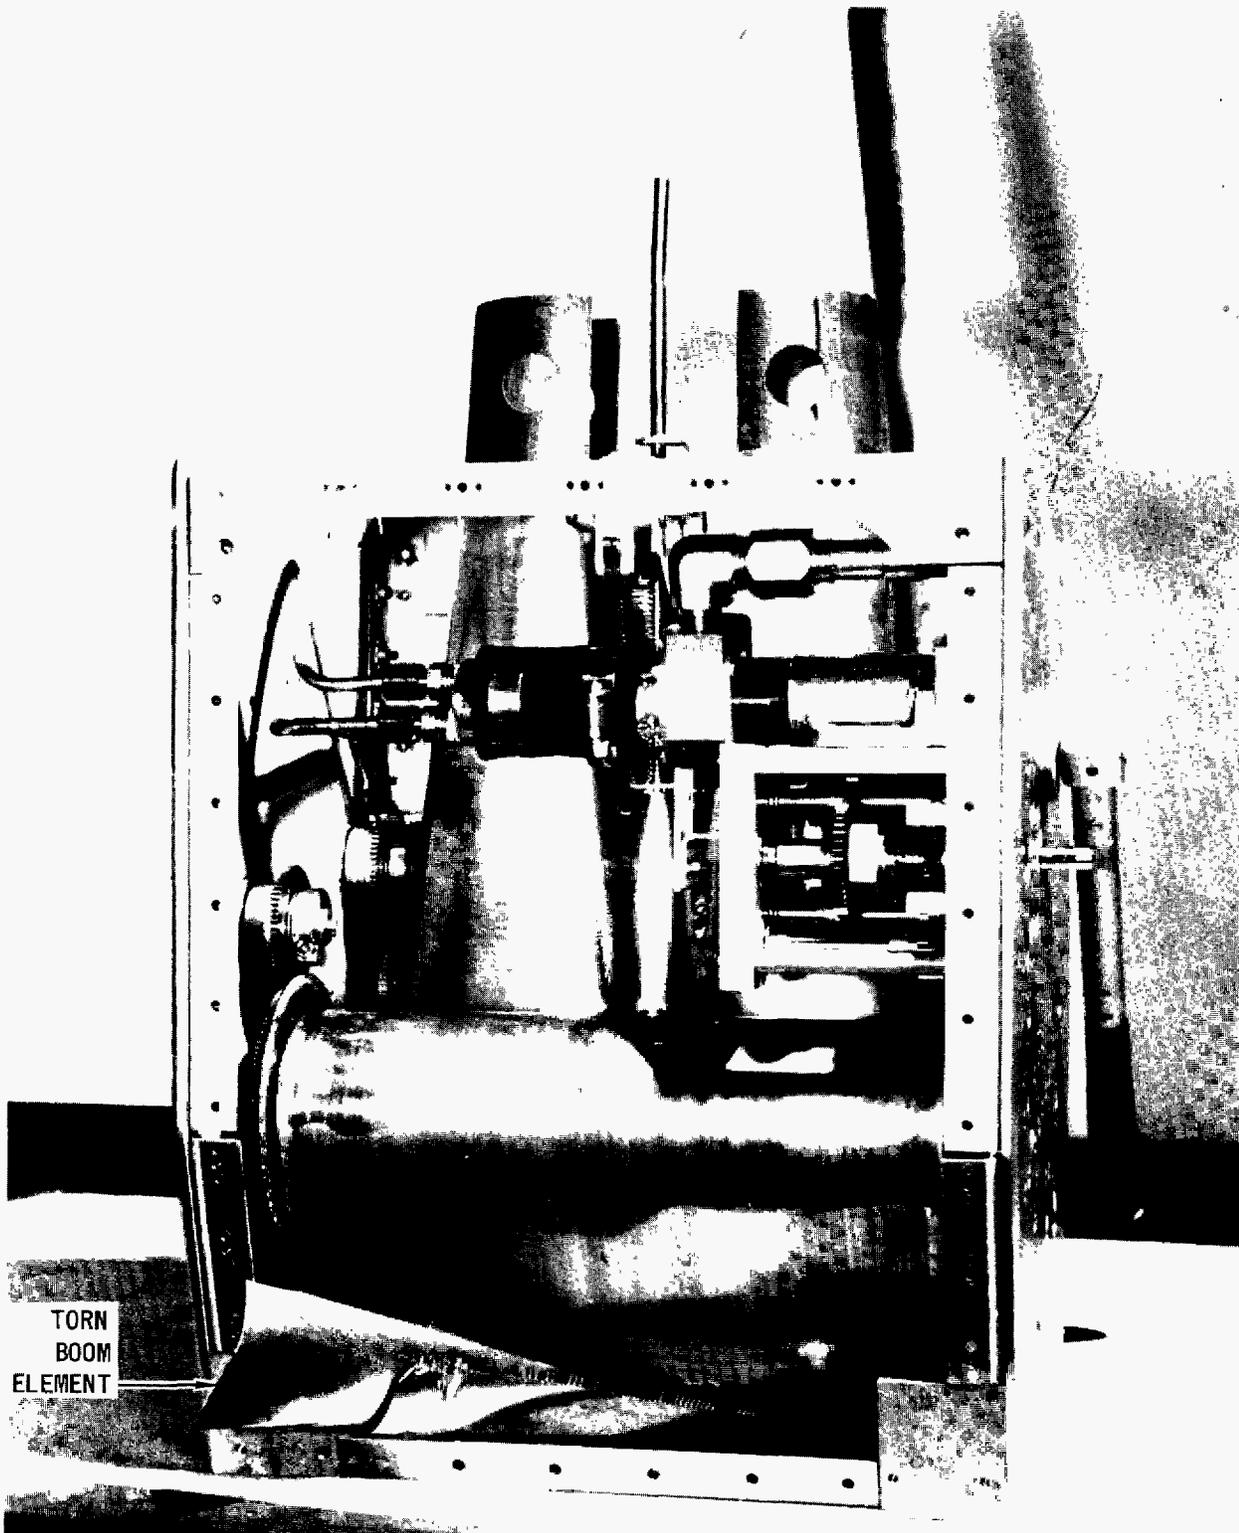
FIGURE 5-3 NBS EXTENDIBLE BOOM (COVER REMOVED)

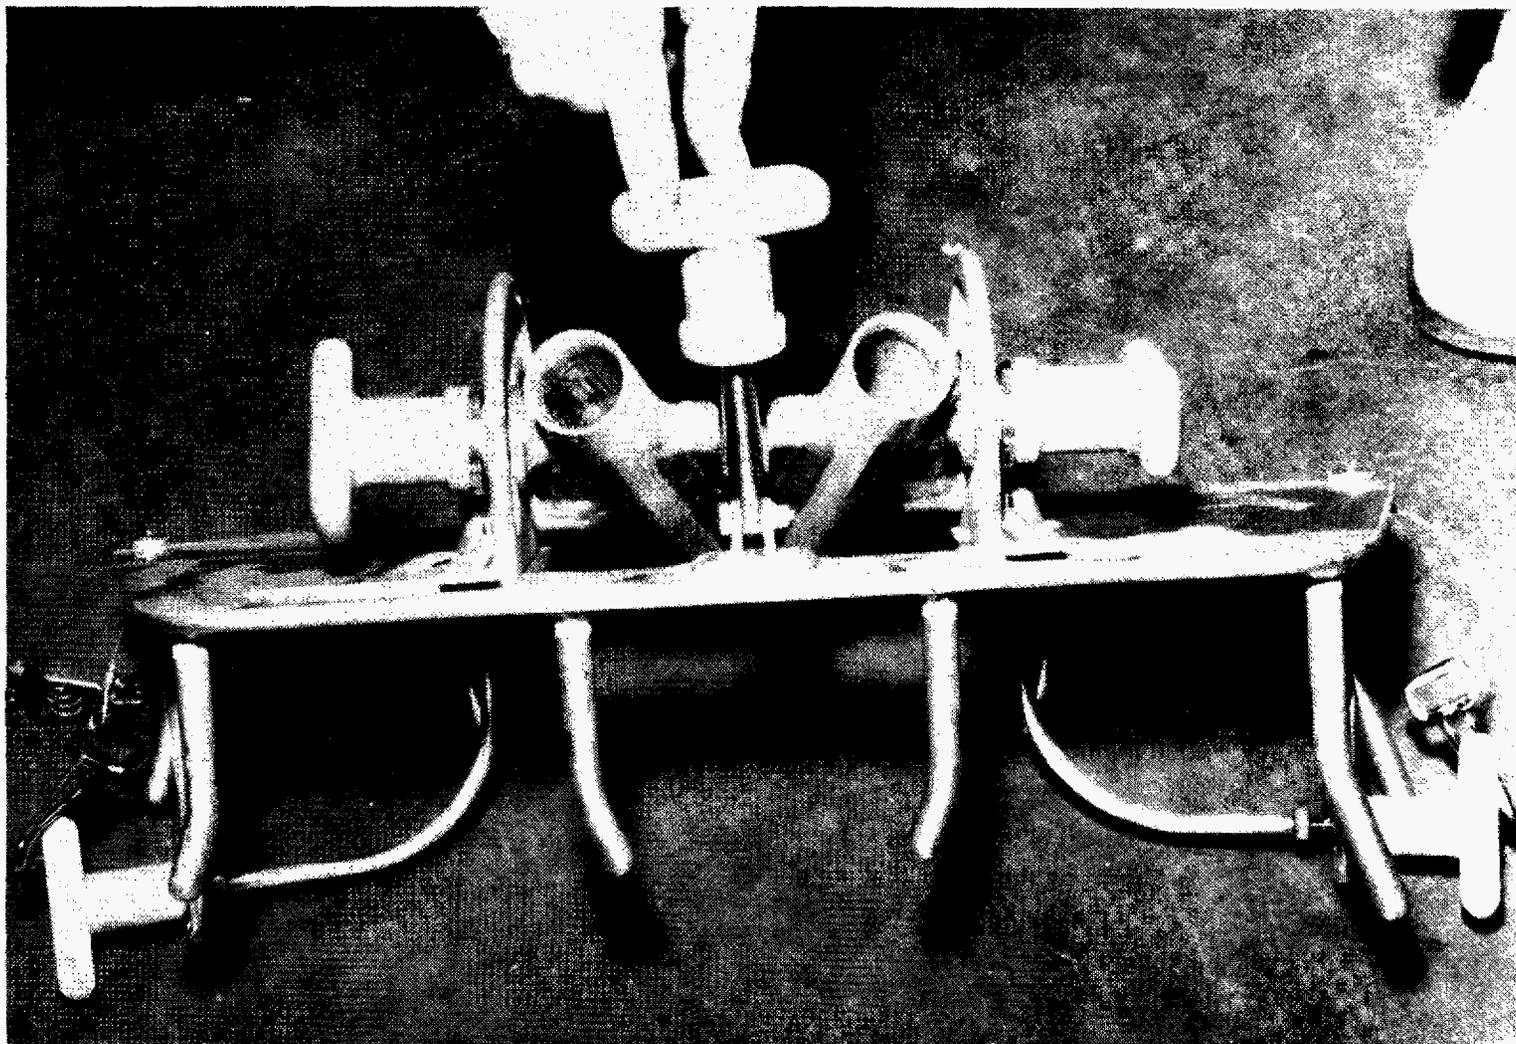
FIGURE 5-12 MSFC TWIN-POLE SAIL "BASE PLATE"

The second concept selected for flight was the MSFC twin-pole sail. This shielding method utilized a covering of aluminized mylar film, coated with a special thermal compound (designated S-13G). The deployment/assembly for the replacement thermal shield consisted of a simple mounting bracket "Base plate" which attached to the ATM A-frame trusses (Figure 5-12). Two 16.6m (55-foot) poles mounted in a "V" position were installed in the "Base plate" and extended to the OWS. A Thermal Shield (sail) 6.7m by 7.3m (22 ft by 24 ft), which was packaged in a large retaining bag, (Figure 5-13), was unfurled by attaching the forward edge of the

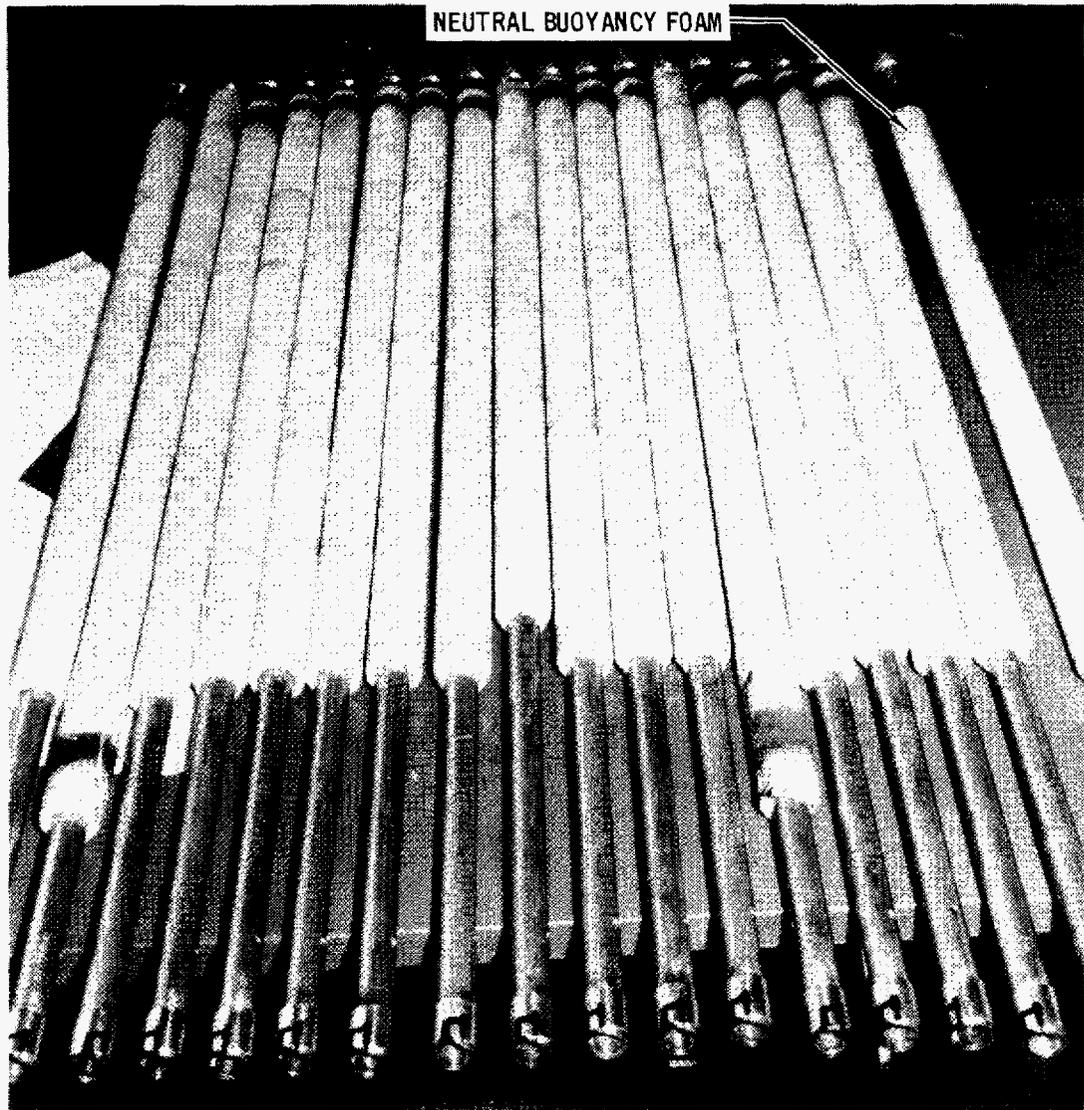
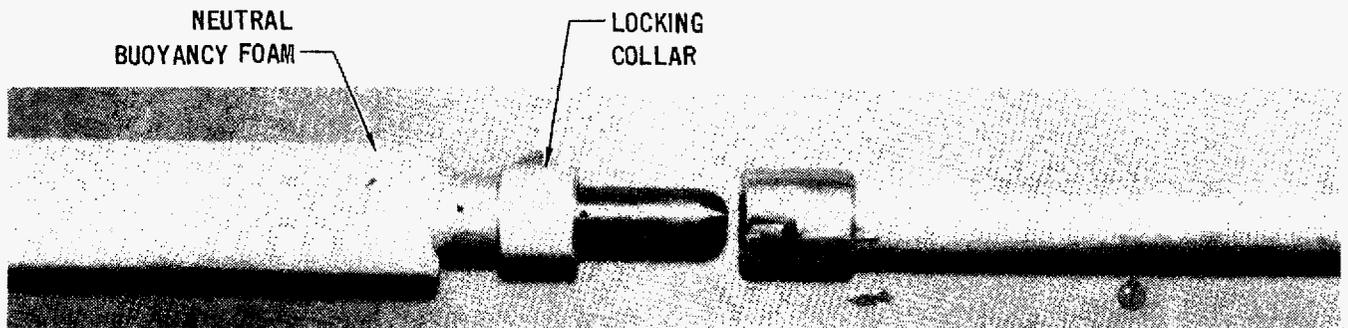
FIGURE 5-15 INTERLOCKING 1.55M (5 FT) SAIL POLES

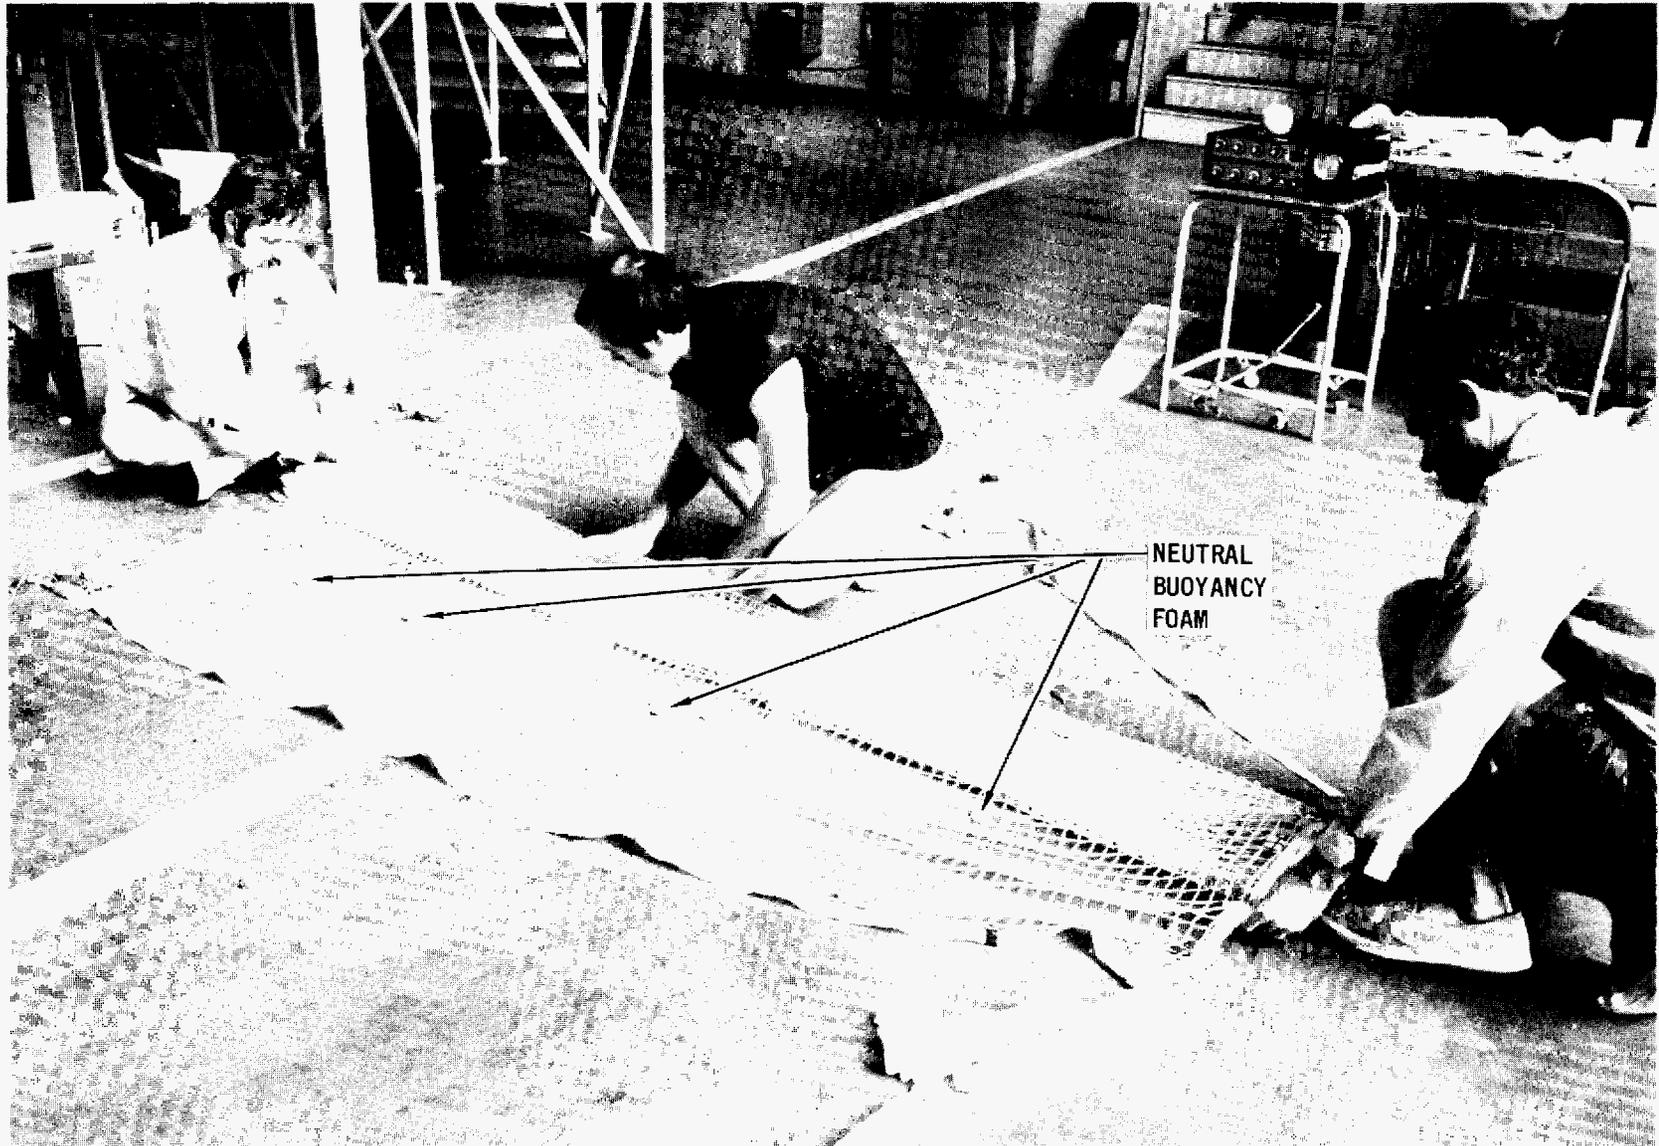
FIGURE 5-16 FOLDING THE NBS TWIN-POLE SAIL
